TECHNICO
Environmental Services, Inc.

Technico Project No. M12 Contamination

**Subject: Site Characterization and Independent Cleanup Action Report
for the Brand X Tank 'n' Tummy, 401 S. Elm Street, Toppenish, WA**

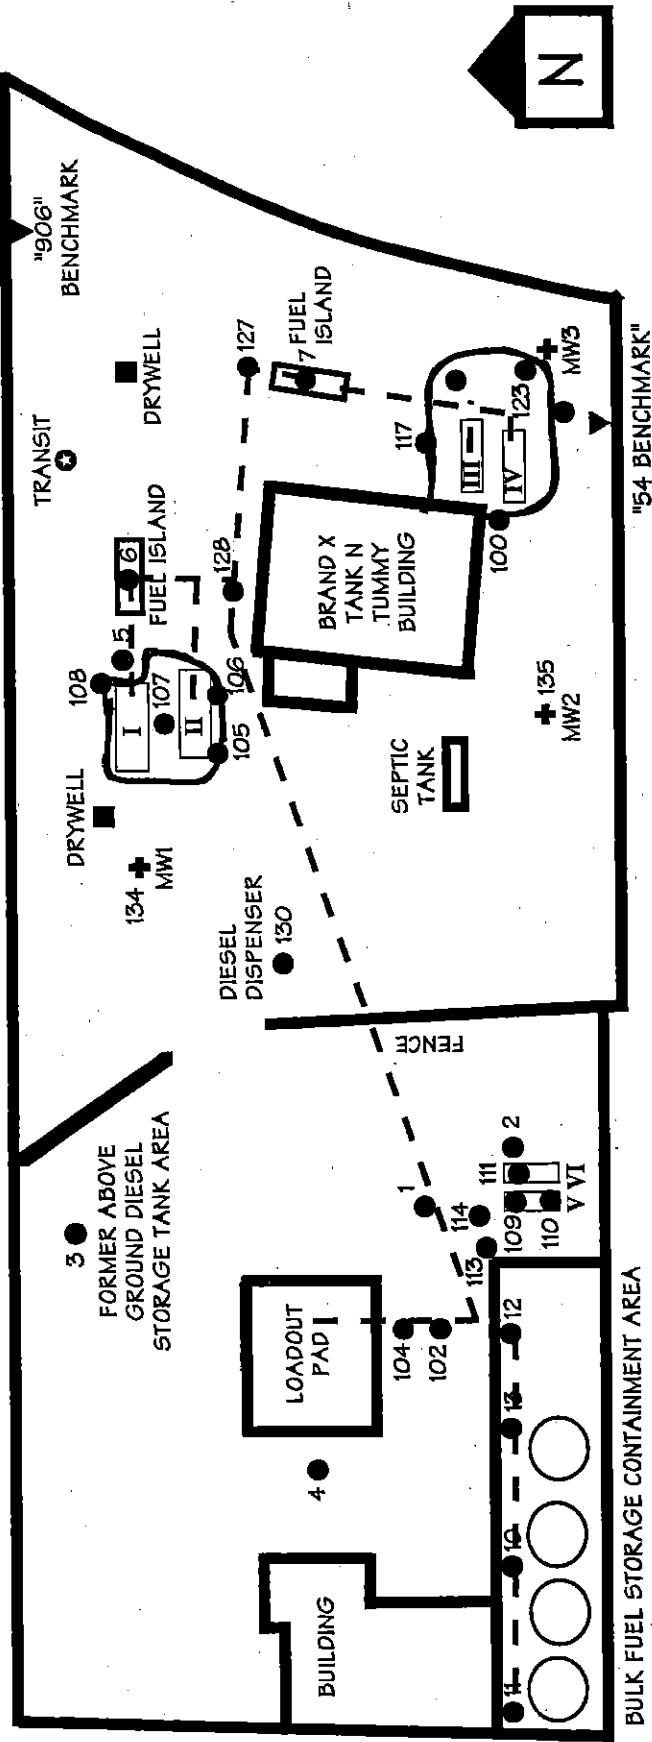
Figure 1
**Site Map of the Brand X Tank 'n' Tummy
in Toppenish, Washington**

Tanks I & II are 6,500 gallons each
 Tanks III & IV are 4,000 gallons each
 Tanks V & VI are 1,000 gallons each

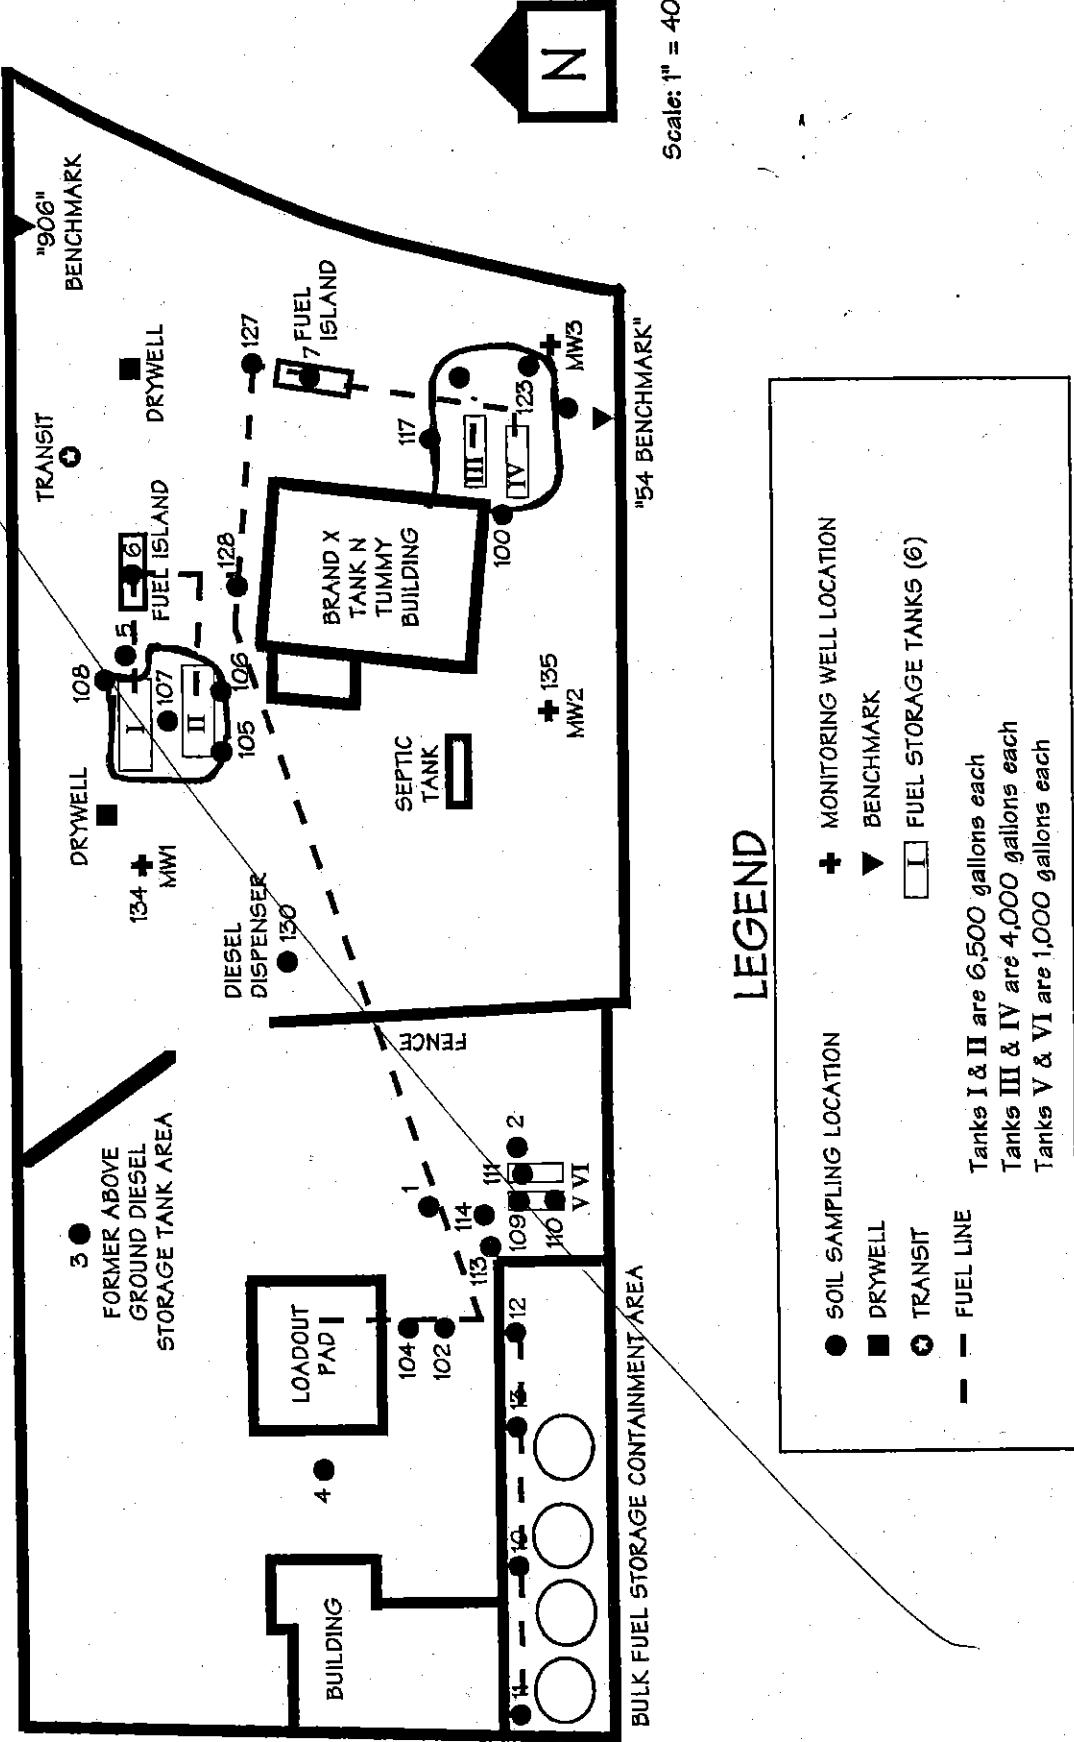
Figure 2
**Site Map of Brand X Tank 'n' Tummy Site in Toppenish, WA
 with Groundwater Elevations, Contours, and Direction of Flow**
August 10, 1995

Groundwater monitoring wells were installed at locations MW1, MW2, and MW3 based upon reported groundwater flows and direction at the Chevron site across Fort Road. Table 3 shows top of casing elevations, static water level, and groundwater elevation measurements taken on April 27, May 2, and July 5, and August 10, 1995. Groundwater has risen about 2 feet since the introduction of irrigation water in early April. Groundwater contours and direction of flow shown on Figure 2 indicate wells MW2 and MW3 are properly placed to detect residual contamination. No diesel was detected in the groundwater..

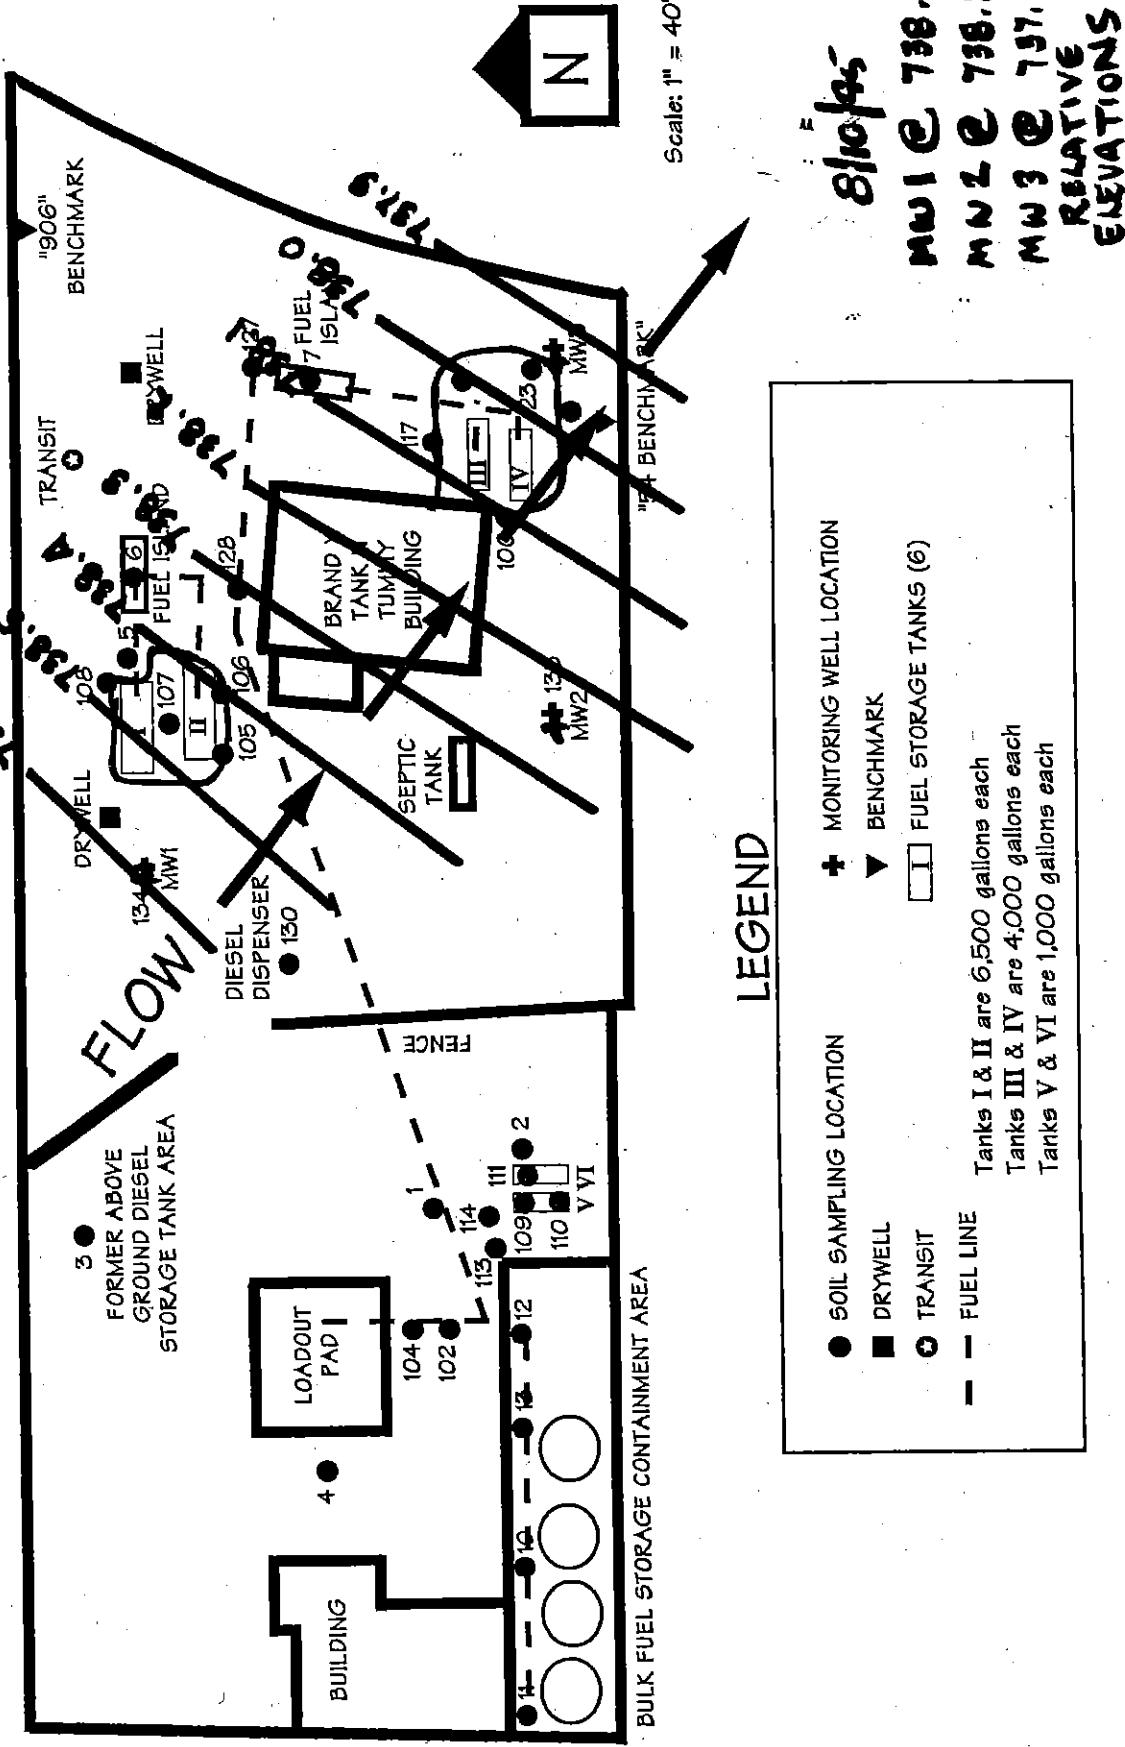
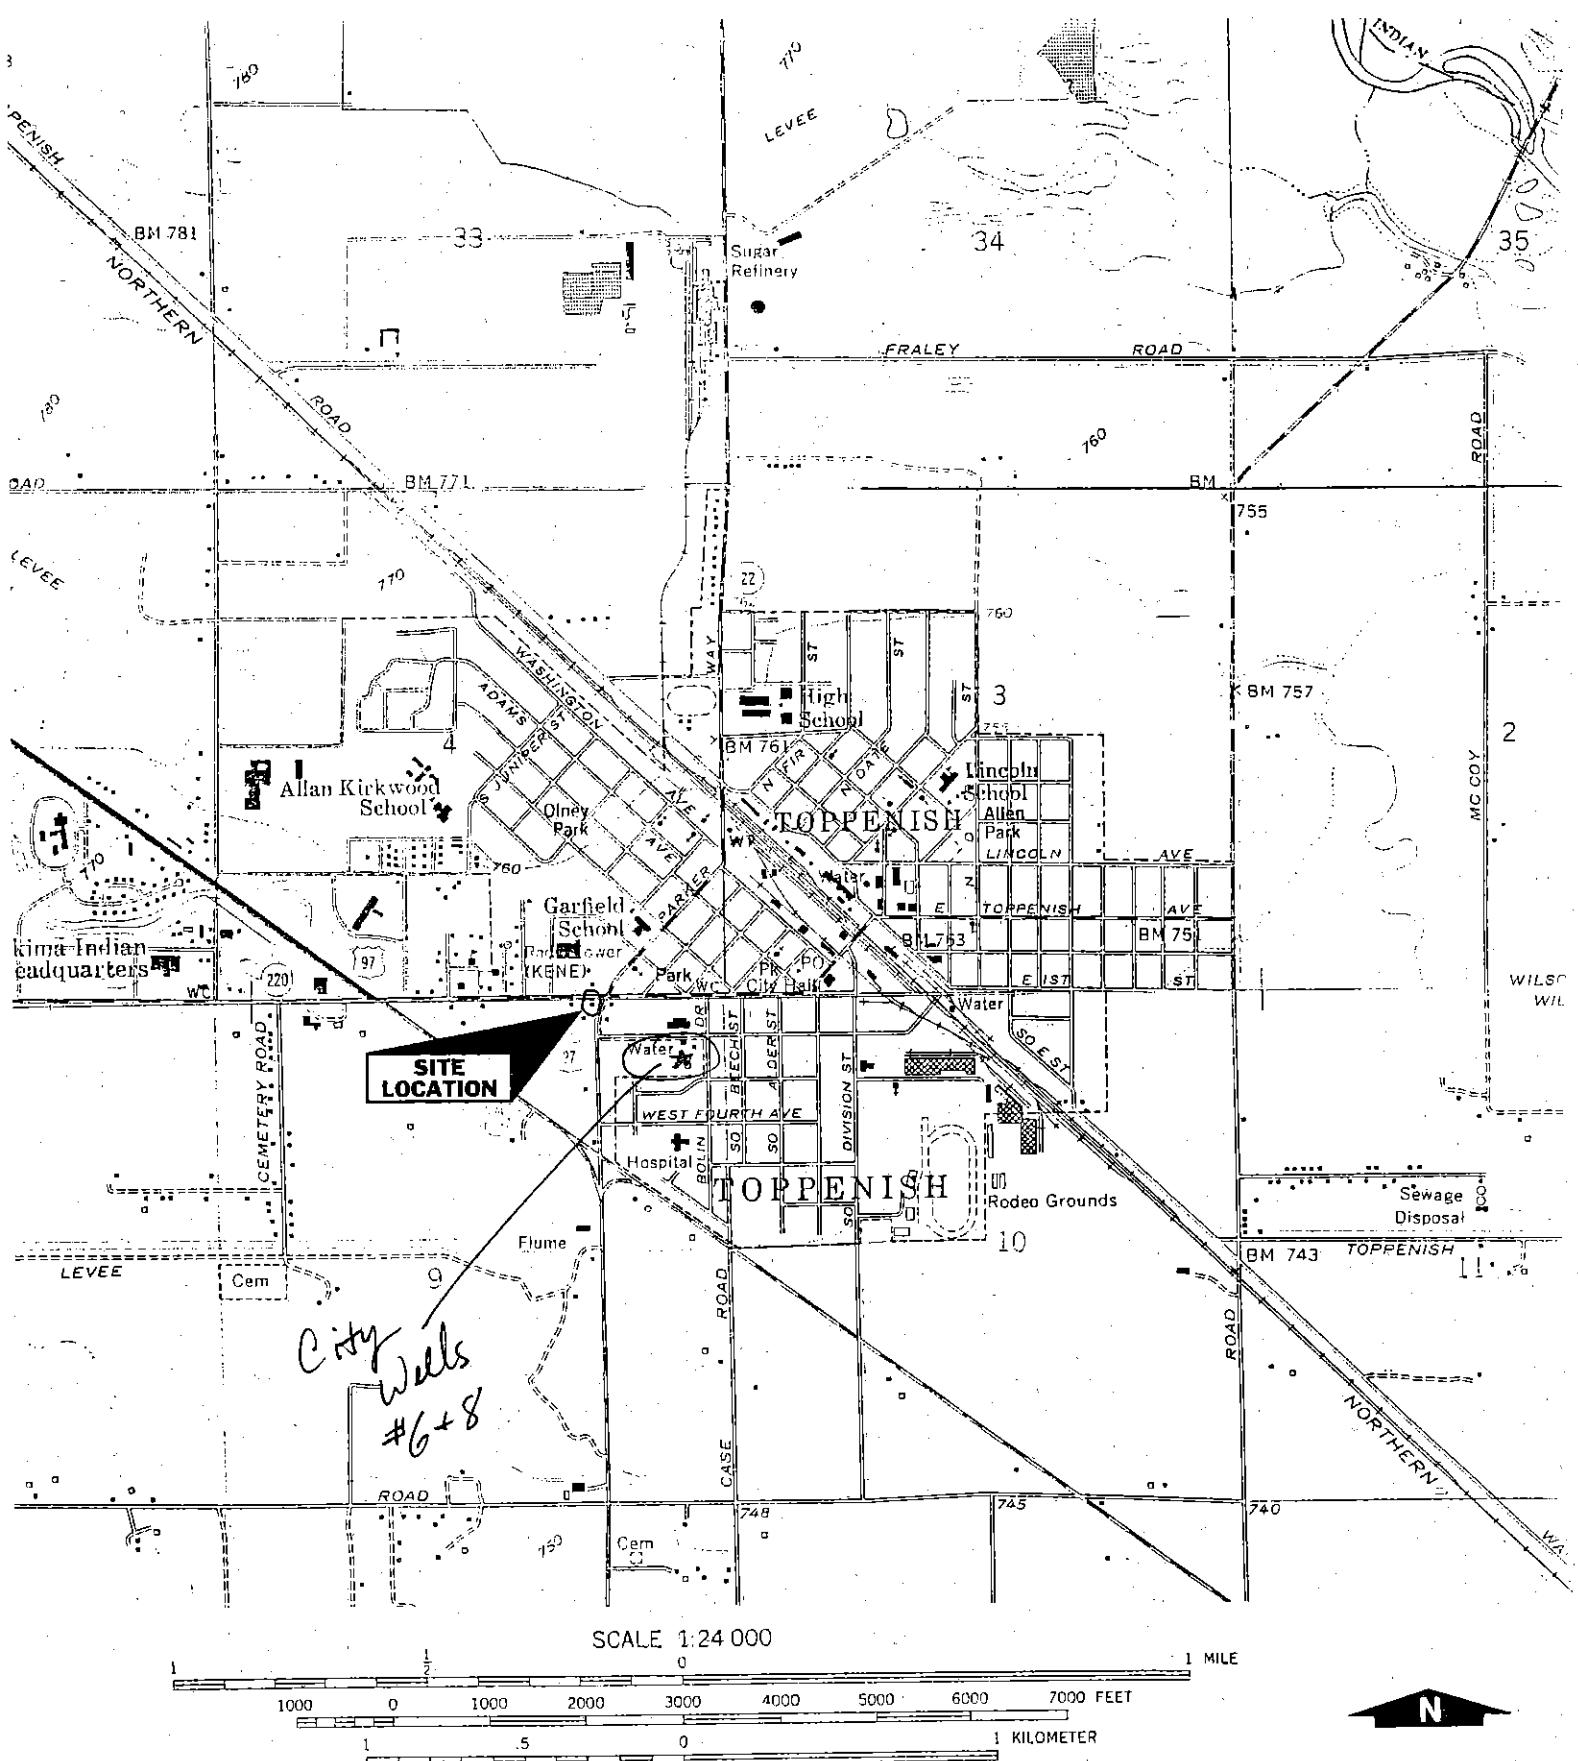
**Figure 3 - Topographical Map
USGS 7.5 minute series**

The only known downgradient user of groundwater in this area is the City of Toppenish which has two wells (wells 6 and 8) indicated by the red star on Figure 3. The wells at this location are screened at a depth of more than 100 feet (see Attachment 1). The wells have been analyzed for BTEX compounds once every 3 years for the last 12 years. Analyses of these wells have indicated no presence of gasoline or BTEX compounds, as shown in Attachment 2.
